ABSALOM DOUGHTY DAM

PHASE I INSPECTION REPORT NATIONAL DAM SAFETY PROGRAM

NJ 00080

APRIL 1978

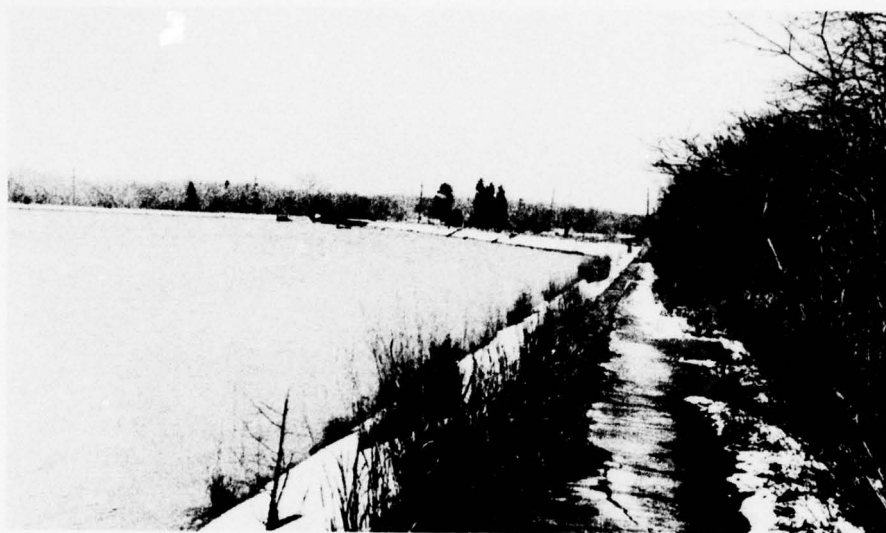
The physical condition of the Absalom Doughty Dam, at the time of the inspection, was very poor. The dam is an earth embankment with a concrete core wall and a steel sheet pile foundation cutoff. It is protected on the upstream slope and crest by concrete slabs, several of which have been displaced. Considerable erosion and some settlement of the embankment has occurred.

OVERALL VIEW OF DAM

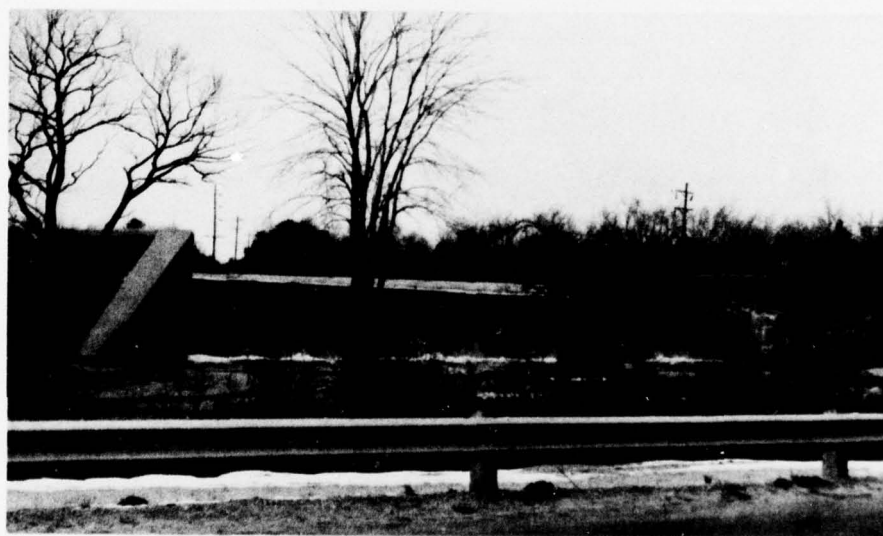
SPILLWAY

c. Appurtenant Structures - The spillway is a concrete ungated overflow structure that appeared to be in good condition at the time of inspection. The adjoining concrete abutments have noticeable age cracks, but appear to be sound.

f. Modify the spillway to pass the spillway design flood ($\frac{1}{2}$ PMF) with an adequate freeboard.

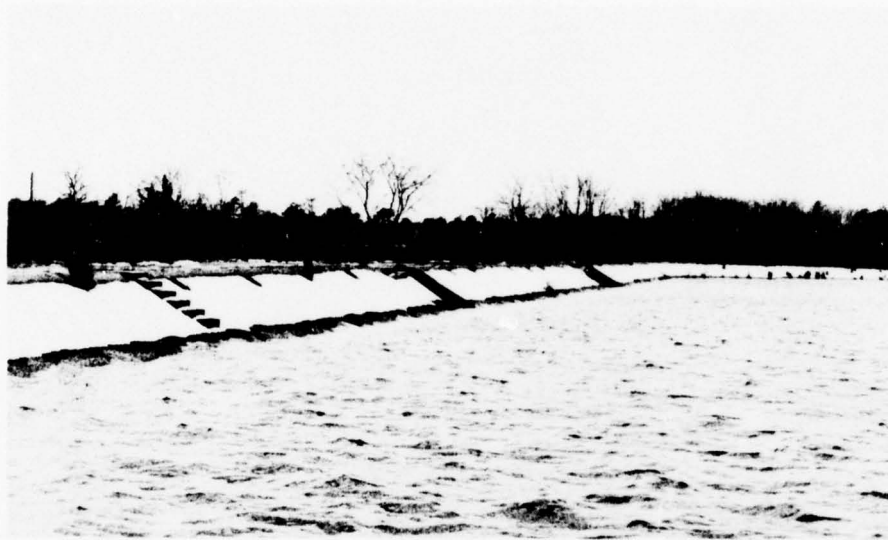
The present condition of Absalom Doughty is poor. A considerable amount of settlement or erosion has occurred along the upstream face of the embankment. Where the concrete slab slope protection has collapsed, the effects of the erosion or settlement are most severe. Strong westerly winds could generate waves of up to 3 feet that could wash away the cohesionless embankment material.

VIEW OF UPSTREAM FACE SHOWING AREAS OF
SLOPE FAILURE

- a. Remove concrete slabs on the upstream slope which have been displaced.
- b. Fill the eroded areas under the slabs with suitable earth materials.
- c. Replace concrete slabs. Graded filter material or filter fabric should be placed over the earth before the slabs are constructed. Expansive filler should be used in the joints of the new slabs.

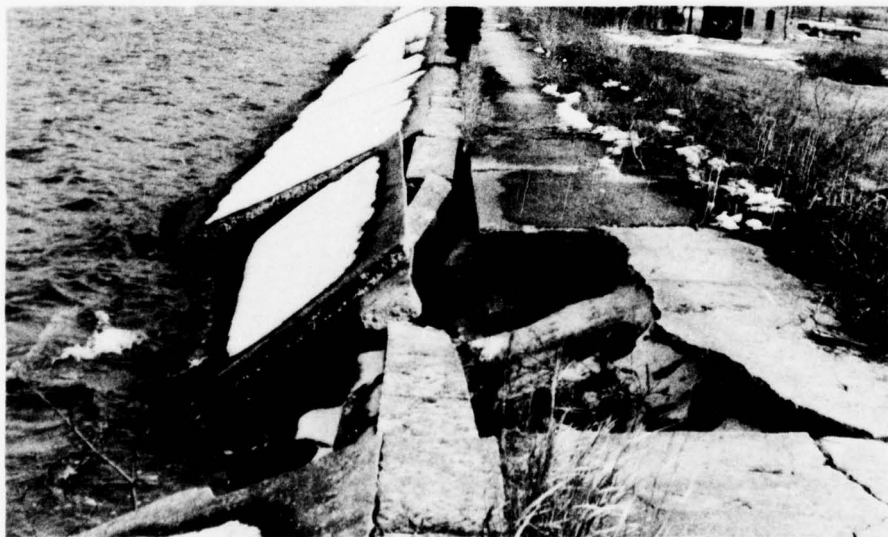
CLOSEUP OF UPSTREAM SLOPE FAILURE

RIPRAP FAILURES	Concrete slabs were used for slope protection. Several slabs have collapsed after considerable embankment settling.	The concrete slab slope protection is in need of repair.

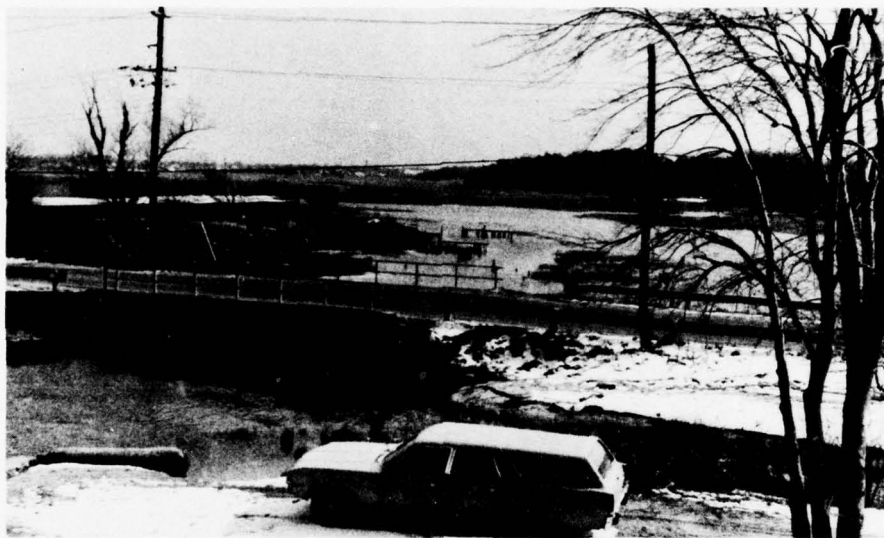
CHANNEL DOWNSTREAM OF SPILLWAY

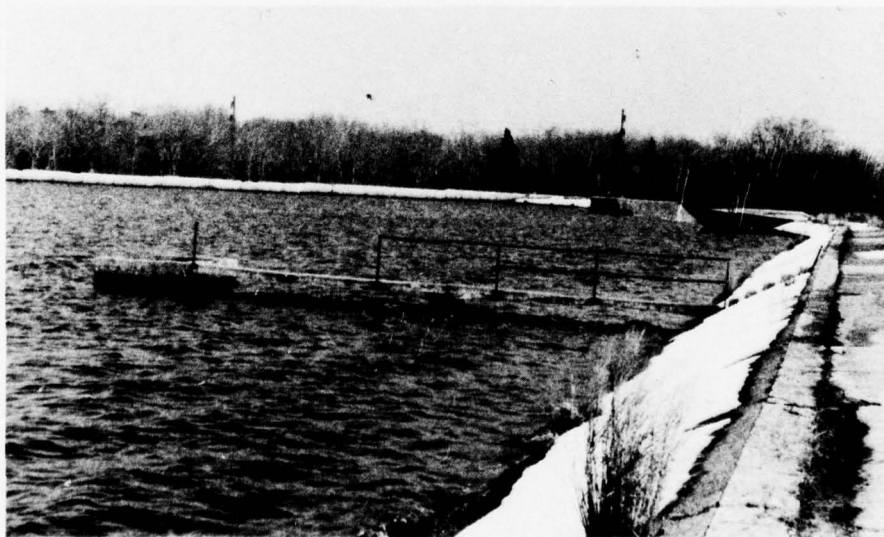
WATER SUPPLY INTAKE

VISUAL EXAMINATION OF	OBSERVATIONS	REMARKS OR RECOMMENDATIONS
CRACKING AND SPALLING OF CONCRETE SURFACES IN OUTLET CONDUIT	Conduit is subsurface.	None
INTAKE STRUCTURE	Water supply intake structure and the walkway to the structure are badly cracked and spalled. Some lengths of the hand railing are missing.	Repair or replacement of the structure should be implemented as merited.
OUTLET STRUCTURE	Thirty-inch blowoff lines are located under the spillway near each abutment. The operating assemblies for these lines are not in place.	The operating assemblies should be permanently in place to allow emergency operation.
OUTLET CHANNEL	Same as spillway discharge channel.	None
EMERGENCY GATE	None	None
